**CANOE BROOK
RESERVOIR NO.2 DAM
NJ 00526**

**PHASE 1 INSPECTION REPORT
NATIONAL DAM SAFETY PROGRAM**

Name of Dam: Canoe Brook Reservoir No. 2,
I.D. No. NJ 00526
State located: New Jersey
County located: Essex
Stream: (Off-stream pumped storage)
Date of Inspection: November 29, December 16, 1978,
and January 4, 1979

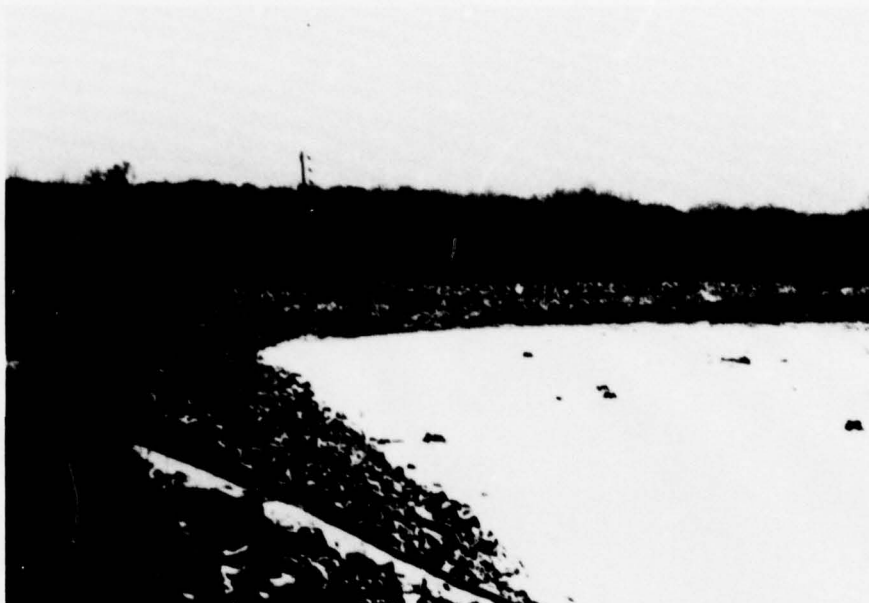
Photo 1 - Southeastern shoreline in area subject to most severe wave action. (11-29-78)

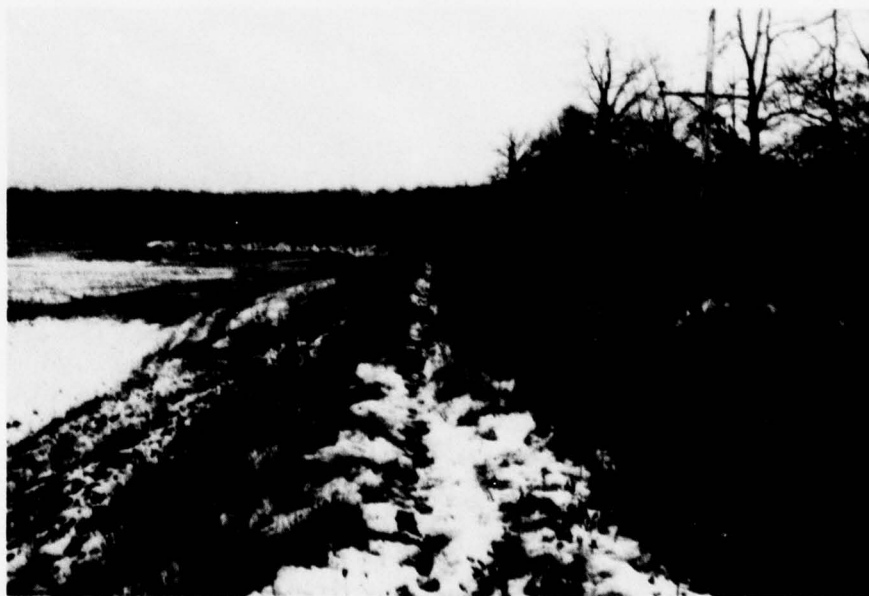
The embankment appears to be in generally good condition. Slopes are reasonably uniform and the in-board riprap, with minor exceptions, is well maintained. Wave action has cut the southeastern embankment to a minor degree. No vertical deflections in the crest could be detected, but the crest in some places is only about 3 feet wide, possibly due to erosion.

Photo 2 - Southern embankment, showing wave-cut inboard slope. (11-29-78)

Irregularities and eroded surfaces on the crest and slopes should be repaired as soon as possible.

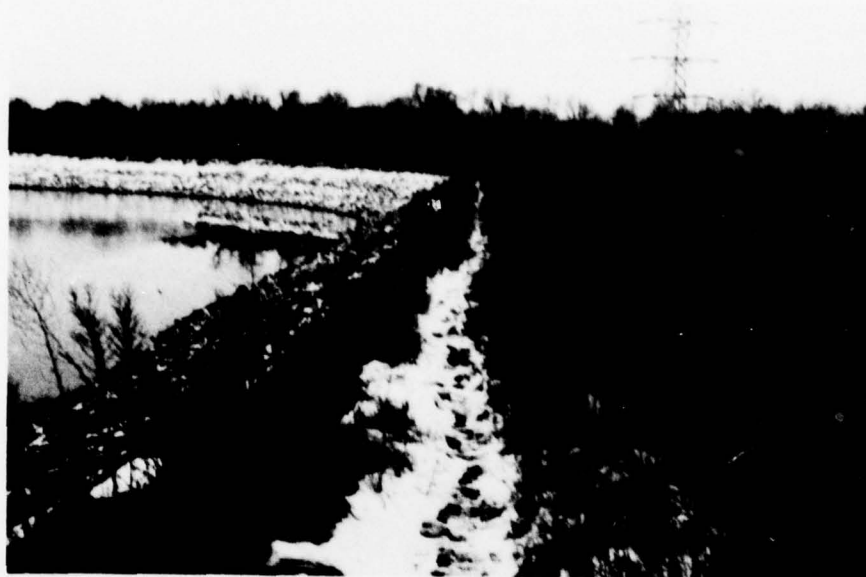
Photo 3 - Northwestern embankment looking west,
showing narrow crest width. (11-29-78)

1. Repair any erosion scars, deformations and settlement areas as indicated by a survey of the embankment, so that the embankment top elevation, width of top and angle of slope conform to the original design.

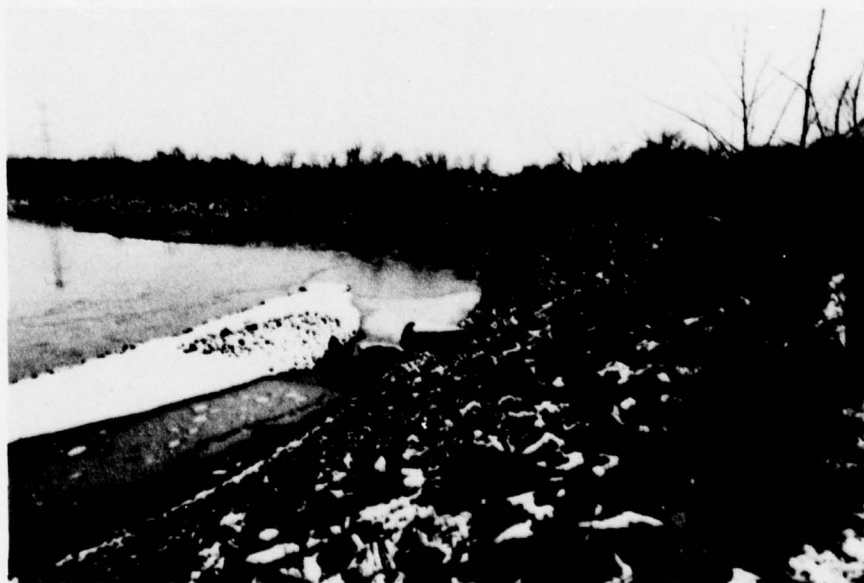
Photo 6 - Inlet of 48-inch transfer pipeline
connecting Canoe Brook Reservoirs Nos. 1 and 2.
(11-29-78)

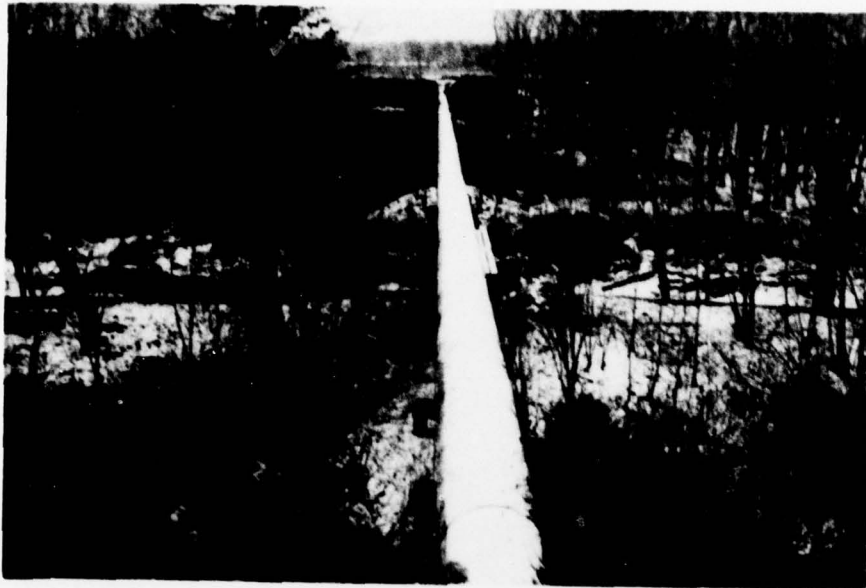
Photo 7 - Elevated portion of 48-inch transfer pipeline, looking toward Canoe Brook Reservoir No. 1. (11-29-78)

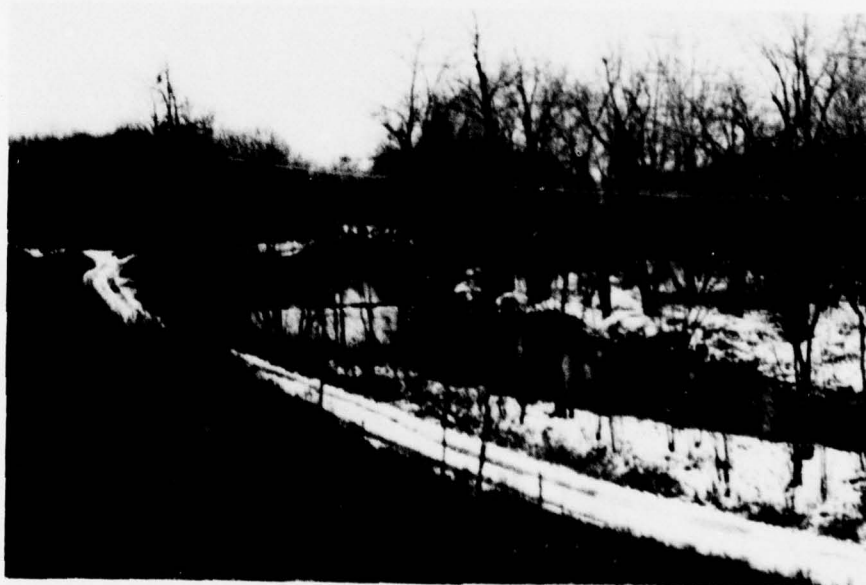
Photo 8 - Passaic River at intake structure. Pump station to left of weir. (11-29-78)

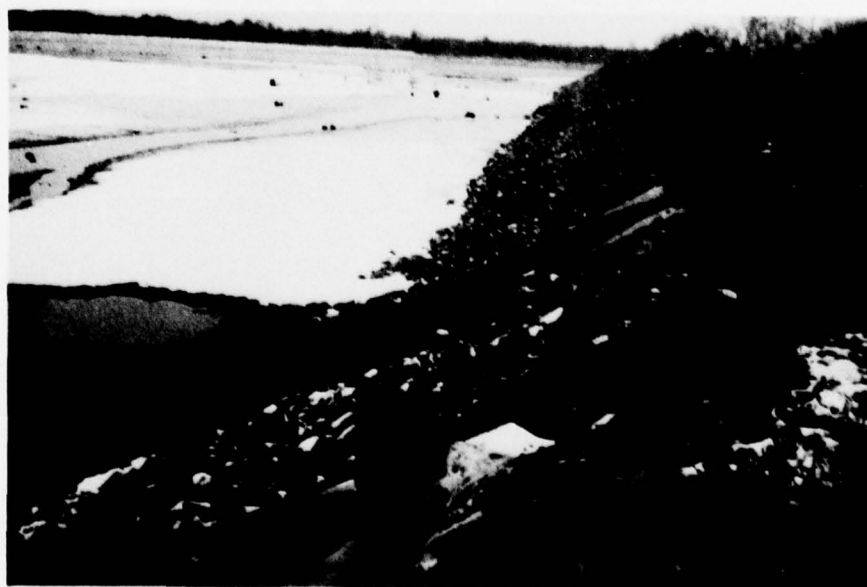
Photo 10 - Outlet pipes for return flow of
washwater from treatment plant filters.
(11-29-78)
